DEPARTMENT OF TRANSPORTATION**DIVISION OF ENGINEERING SERVICES**

Contract #: 04-0120F4Cty: SF/ALA Rte: 80 PM: 13.2/13.9File #: 69.28**WELDING INSPECTION REPORT****Resident Engineer:**Pursell, Gary**Address:** 333 Burma Road**City:** Oakland, CA 94607**Report No:** WIR-002721**Date Inspected:** 28-Jun-2008**Project Name:** SAS Superstructure**OSM Arrival Time:** 2300**Prime Contractor:** American Bridge/Fluor Enterprises, a JV**OSM Departure Time:** 730**Contractor:** Zhenhua Port Machinery Company, Ltd (ZPMC), Changxing Island **Location:** Shanghai, China**CWI Name:** Wu Ming Kai, Lu Hua Jie**CWI Present:** Yes No**Inspected CWI report:** Yes No N/A**Rod Oven in Use:** Yes No N/A**Electrode to specification:** Yes No N/A**Weld Procedures Followed:** Yes No N/A**Qualified Welders:** Yes No N/A**Verified Joint Fit-up:** Yes No N/A**Approved Drawings:** Yes No N/A**Approved WPS:** Yes No N/A**Delayed / Cancelled:** Yes No N/A**Bridge No:** 34-0006**Component:** Caltrans OBG, Tower**Summary of Items Observed:**

OBG – Bay 2

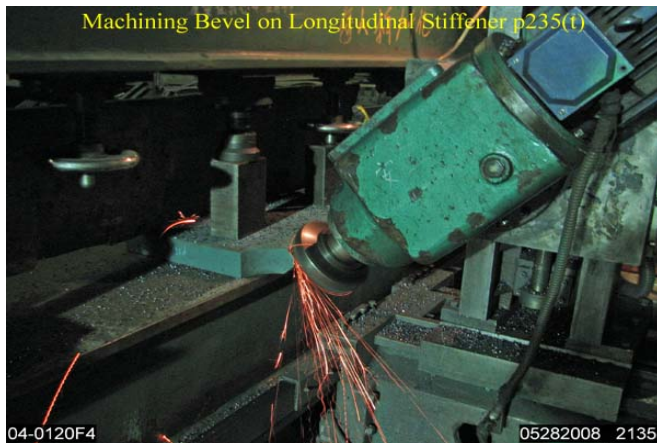
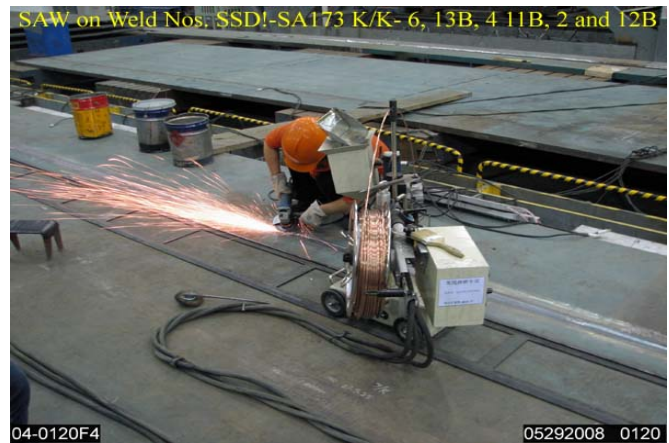
The Caltrans QA Inspector randomly observed the machine Submerged Arc Welding (SAW) of fill passes on Weld Nos. SSD1-SA173 K/K-6, 13B, 4, 12B, 11B and 2. All eight welds are on the same joint and appear to be numbered as such because they alternate partial joint penetration (PJP) and complete joint penetration (CJP) along the joint. The "B" welds are CJP and the welds without a letter designation are PJP. The welding operator was Liu Zheng hong (I. D. No. 053673). The welding was in the flat groove (1G) position using Welding Procedure Specification (WPS) Nos. WPS-B-T-2221-B-U3c-S for the CJP; and WPS-B-T-2221-B-P3-S for the PJP. Certified Welding Inspector (CWI), Liu Hua Jie (CWI No. 07120741) was present during this welding as was ABF QA Inspector, Xie Yan.

All above observations appeared to meet the requirements of the job specifications.
